# Manhole Inspection Summary

Manhole # S27M\_\_003MH

Insp Date: **5/5/08 9:35 AM**

**Location** Address: **1222 W Ostend St**

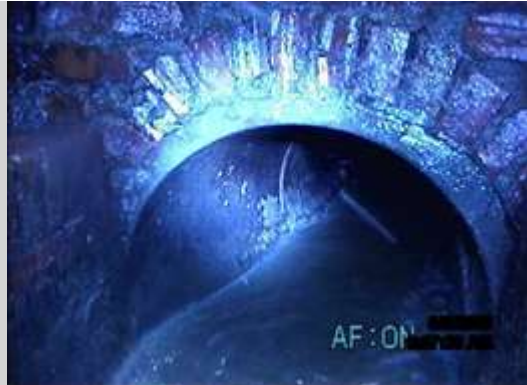
12 O'Clock Outflow

24 in. Circular Gravity Sewer  
Pipe Out @ 12 O'Clock

Pipe Height: **22.8** (in.) Rod and Bar (Angled)  
Pipe Material: **Clay** ☐ Pipe Lined  
Invert Depth: **14.85** (ft.) Flow Characteristics: **Fast**  
Deposits: ☒ None ☐ Mud ☐ Sludge ☐ Debris ☐ Grease  
Silt Depth: **0** (in.) Deposits Extent:  
Infiltration: **None** Pipe Seal Cond: **Sound**

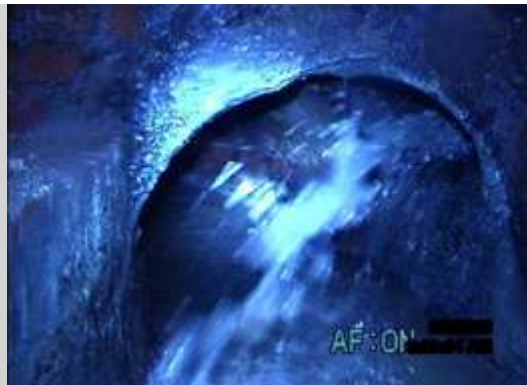
5 O'Clock Inflow

Comments **The MH is constucted in a way that a 10inch pipe is tapped in the main 22inch line see pics, 6oclock pipe is tapped in the 22inch line that is located at 5oclock it looks like one pipe but two are connected**

24 in. Circular Gravity Sewer  
Pipe In @ 5 O'Clock

Pipe Height: **22.8** (in.) Rod and Bar (Angled)  
Pipe Material: **Clay** ☐ Pipe Lined  
Invert Depth: **14.90** (ft.) Flow Characteristics: **Fast**  
Deposits: ☒ None ☐ Mud ☐ Sludge ☐ Debris ☐ Grease  
Silt Depth: **0** (in.) Deposits Extent:  
Infiltration: **None** Pipe Seal Cond: **Unknown**
